Crash Test Between a 6-KG/M U-Channel Sign Support and a 1997 Geo Metro: FOIL Test Number 99F007

PUBLICATION NO. FHWA-RD-01-049

MARCH 2001

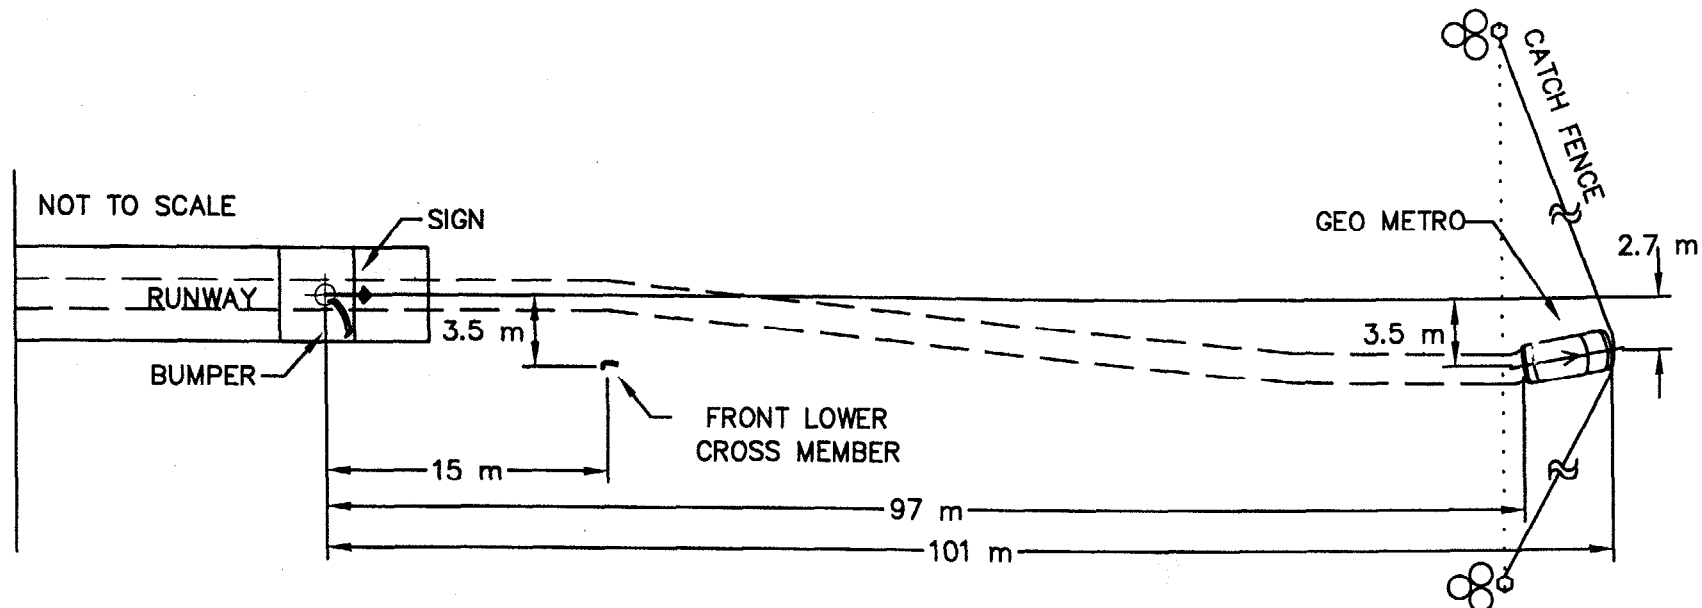
Figure 4. Summary of results, test 99F007.

The results summarized in figure 4 indicate that the 6-kg/m small sign support embedded in strong soil did not meet the safety performance criteria outlined in *NCHRP Report 350* (test designation 3-61). The sign support did not fracture as anticipated and the longitudinal OIV (5.2 m/s) was higher than the allowable limit (5.0 m/s). Table 6 summarizes the safety performance of the small sign support.

Vehicle Damage:
 Traffic Accident Data (TAD).....12-FC-4
 Vehicle Damage Index (VDI).....12FCEN3
 Static crush.....305 mm
 Post fracture.....460 mm vertical tear in web

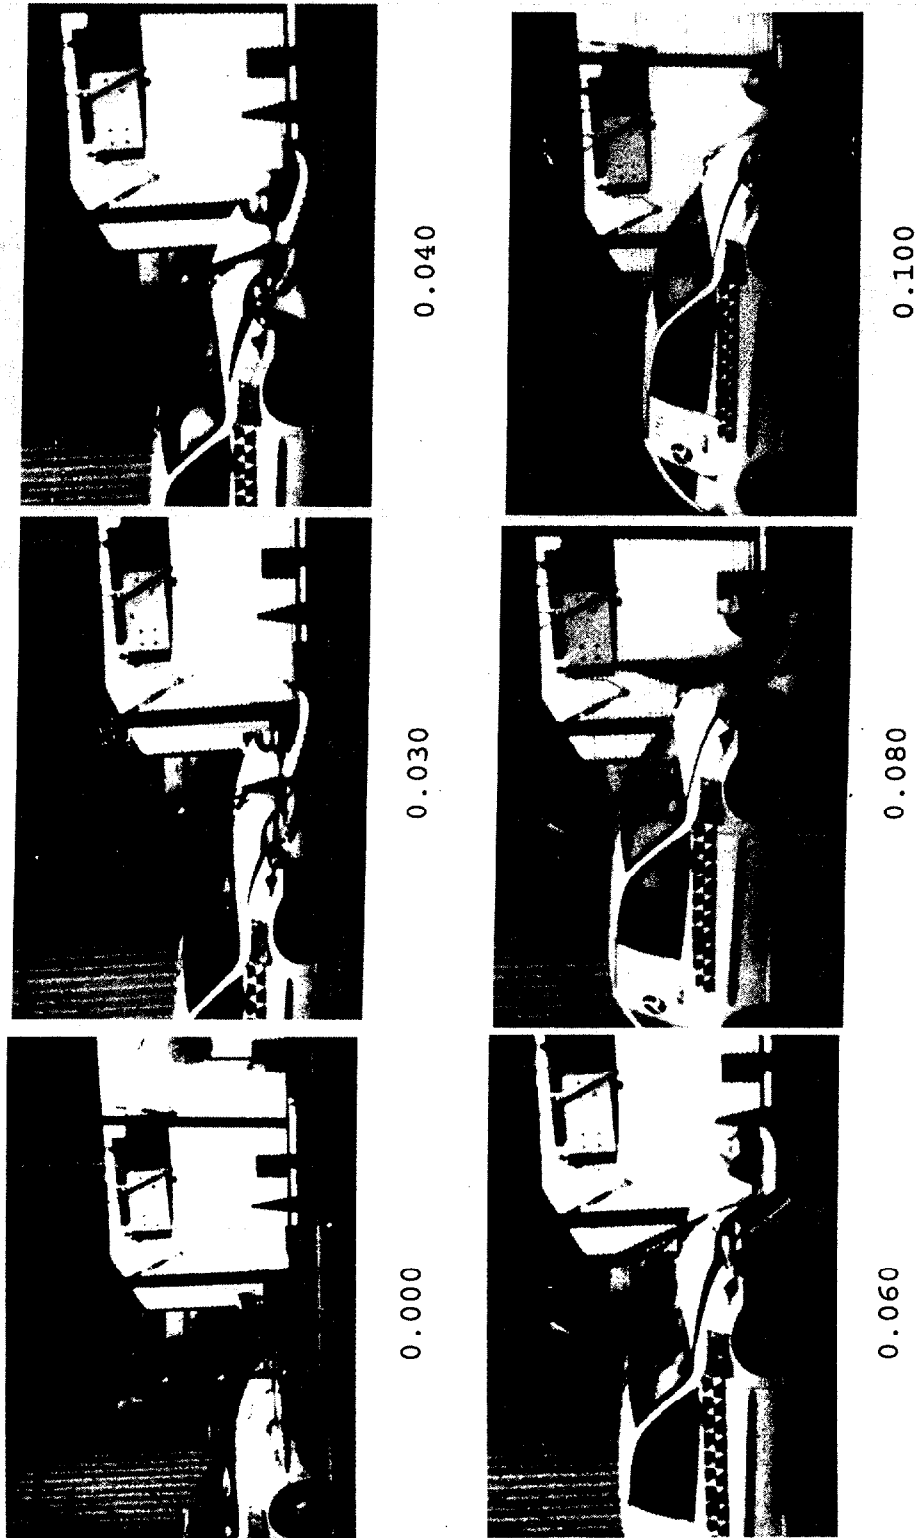
Figure 5. Test photographs during impact, test 99F007.

The Geo Metro was positioned on the runway and attached to the FOIL propulsion system. The windows were up, the emergency brake was released, and the ignition was in the "on" position to activate the air-bags. The vehicle was accelerated to 99.0 km/h prior to striking the small sign support. The vehicle made first contact with the sign post 50 mm to the left of the vehicle centerline. The vehicle bumper began to collapse on contact with the sign support. At 0.010 s after contact the bumper had been pushed back to the radiator while the sign post was slightly bowed and had begun to plow through the soil. The sign post and the plowing action imparted enough force on the vehicle to deploy the air-bags (0.034 s). The vehicle continued to flatten the sign post. By 0.050 s the sign panel had been drawn down to the vehicle's hood but the sign panel did not slap the hood or

windshield. The vehicle flattened the sign post and passed over the sign support by 0.102 s. The vehicle's bumper was torn from the vehicle as the sign post wrapped around the vehicle's front-end. The vehicle passed over the sign support continuing forward on its original trajectory into the FOIL run-out area where the brakes were applied. The vehicle remained stable and upright. The vehicle came to rest after contact with the FOIL catch fence 101 m downstream from the impact location. Figure 4 summarizes the results from the small sign support test. Appendix A contains photographs of the test during the collision and the pre- and post-test environments. Table 5 lists the maximum and minimum peak values obtained from the vehicle accelerometers. The values listed are Class 180 data (digital filter cut-off frequency of 300 Hz). Appendix B contains data plots of the data collected from each vehicle sensor and velocity and displacement data plots created from the longitudinal c.g. acceleration trace. All acceleration data plots are from Class 180 data.
